August 23, 2023

ARBORIST REPORT  
7301 Lundy's Lane, Niagara Falls, Ontario

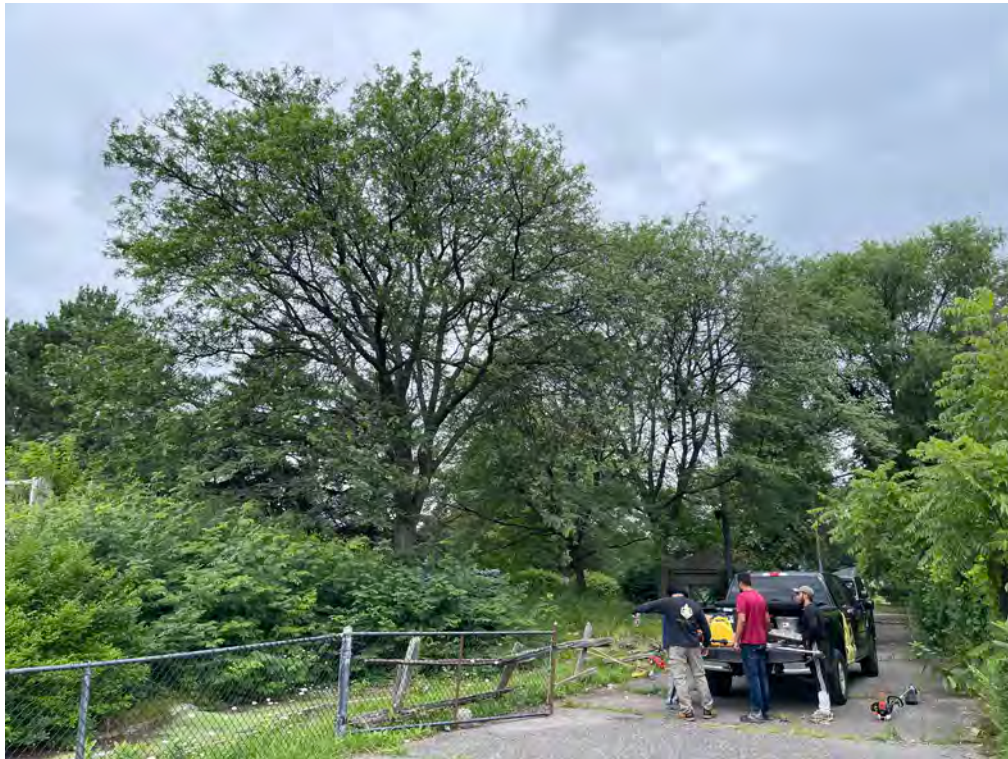
Trees 922, 923

| Tree # | Common Name | Botanical Name | DBH (CM) | Condition | Comments | Recommendation |
|---|---|---|---|---|---|---|
| 922 | Honey Locust | Gleditsia triacanthos | 38 | F | Moderate deadwood in canopy | Remove due to construction |
| 923 | Honey Locust | Gleditsia triacanthos | 58 | F | Moderate deadwood in canopy | Remove due to construction |

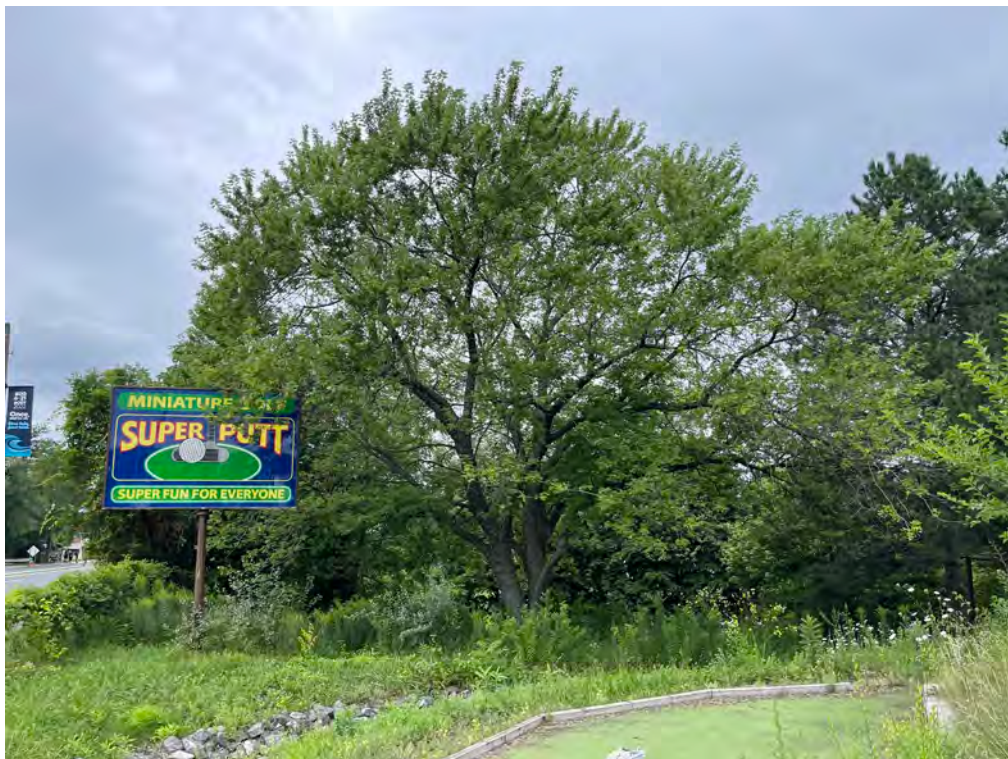
Tree 924

| Tree # | Common Name | Botanical Name | DBH (CM) | Condition | Comments | Recommendation |
|---|---|---|---|---|---|---|
| 924 | Silver Maple | Acer saccharinum | 66 | F | 3 stem at 0.9 metres, minor deadwood in canopy | Remove due to construction |

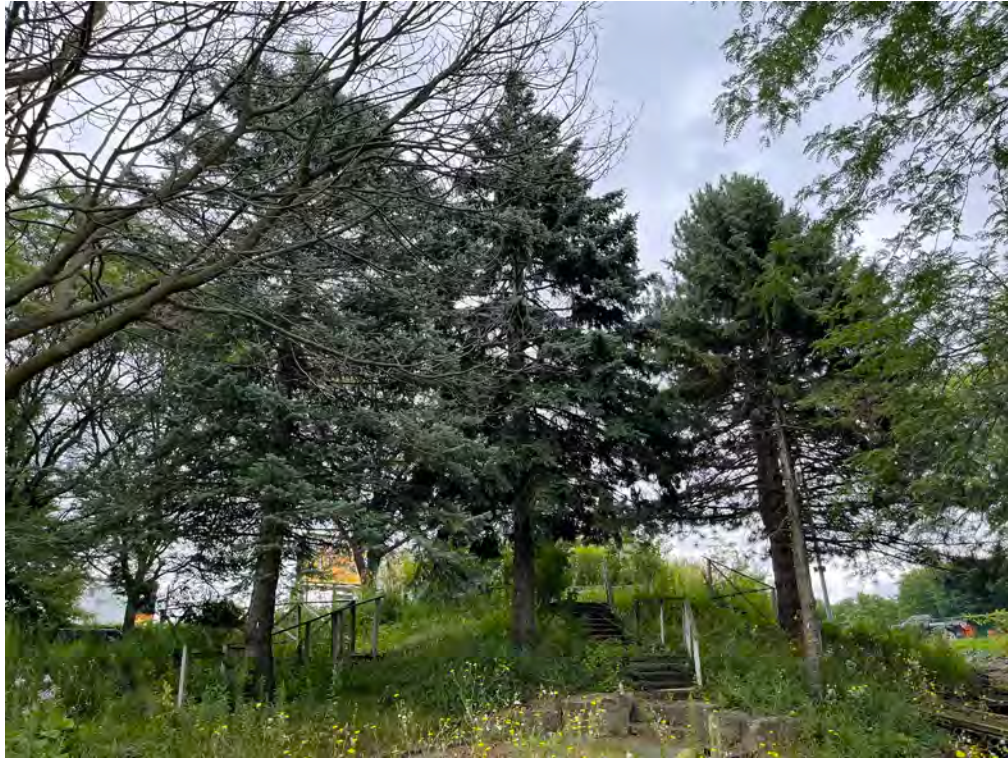
Trees 925 – 928

| Tree # | Common Name | Botanical Name | DBH (CM) | Condition | Comments | Recommendation |
|---|---|---|---|---|---|---|
| 925 | Austrian Pine | Pinus nigra | 59 | F/P | Moderate to significant deadwood in canopy | Remove due to construction |
| 926 | White Spruce | Picea glauca | 26 | F/P | Elevated canopy, moderate to significant deadwood in canopy | Remove due to construction |
| 927 | Colorado Blue Spruce | Picea pungens var. glauca | 43 | F | Moderate deadwood in canopy | Remove due to construction |
| 928 | Colorado Blue Spruce | Picea pungens var. glauca | 40 | F/P | Moderate to significant deadwood in canopy | Remove due to construction |

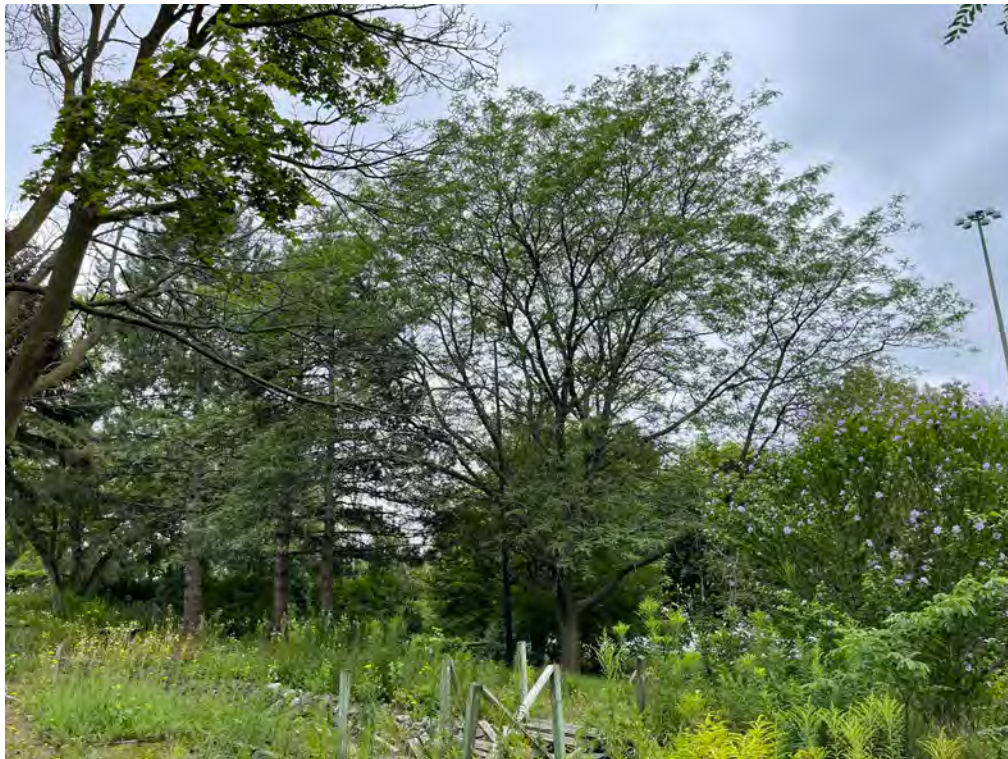
Trees 929 – 932

| Tree # | Common Name | Botanical Name | DBH (CM) | Condition | Comments | Recommendation |
|---|---|---|---|---|---|---|
| 929 | Austrian Pine | Pinus nigra | 48 | F/P | Significant deadwood in canopy | Remove due to construction |
| 930 | Austrian Pine | Pinus nigra | 48 | P | Significant deadwood in canopy | Remove due to construction |
| 931 | Austrian Pine | Pinus nigra | 31 | P | Significant deadwood in canopy | Remove due to construction |
| 932 | Honey Locust | Gleditsia triacanthos | 52 | F | Minor to moderate deadwood in canopy | Remove due to construction |

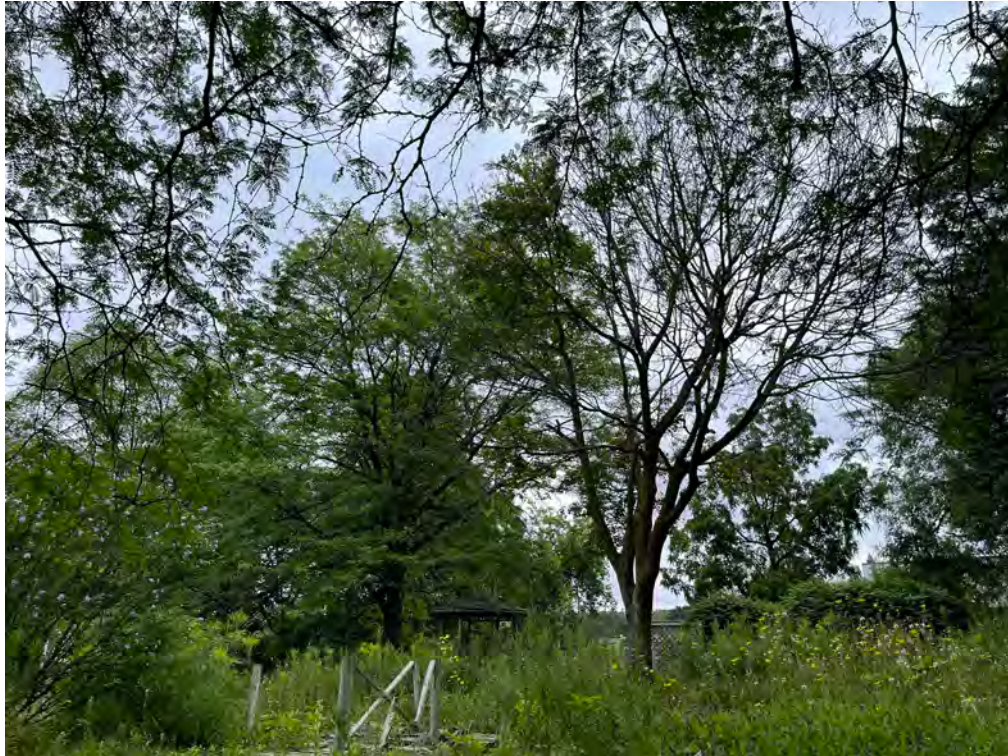
Trees 933, 934

| Tree # | Common Name | Botanical Name | DBH (CM) | Condition | Comments | Recommendation |
|---|---|---|---|---|---|---|
| 933 | Norway Maple | Acer platanoides | 49 | P/D | Tree is 85% dead, significant deadwood in canopy, cavity in trunk, internal rot evident | Remove due to condition |
| 934 | Honey Locust | Gleditsia triacanthos | 58 | F | Minor deadwood in canopy | Remove due to construction |

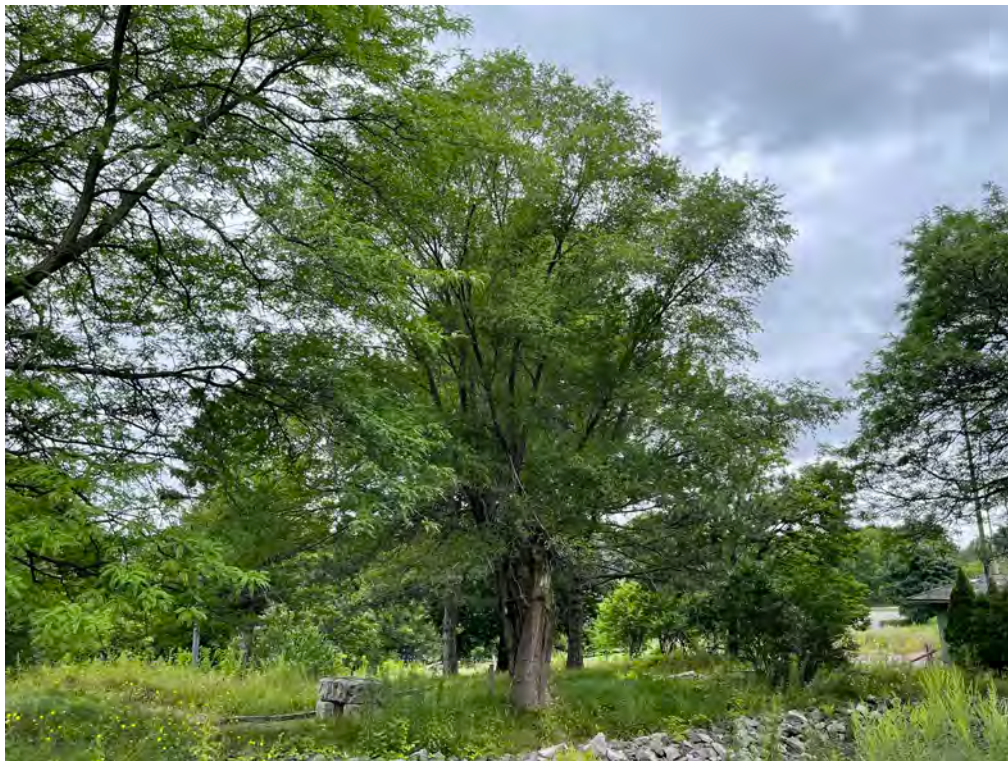
Tree 935

| Tree # | Common Name | Botanical Name | DBH (CM) | Condition | Comments | Recommendation |
|---|---|---|---|---|---|---|
| 935 | Siberian Elm | Ulmus pumila | 97 | F/P | Co-dominant at 1.2 metres, multiple limbs previously failed, cavity in trunk, minor deadwood in canopy | Remove due to construction |

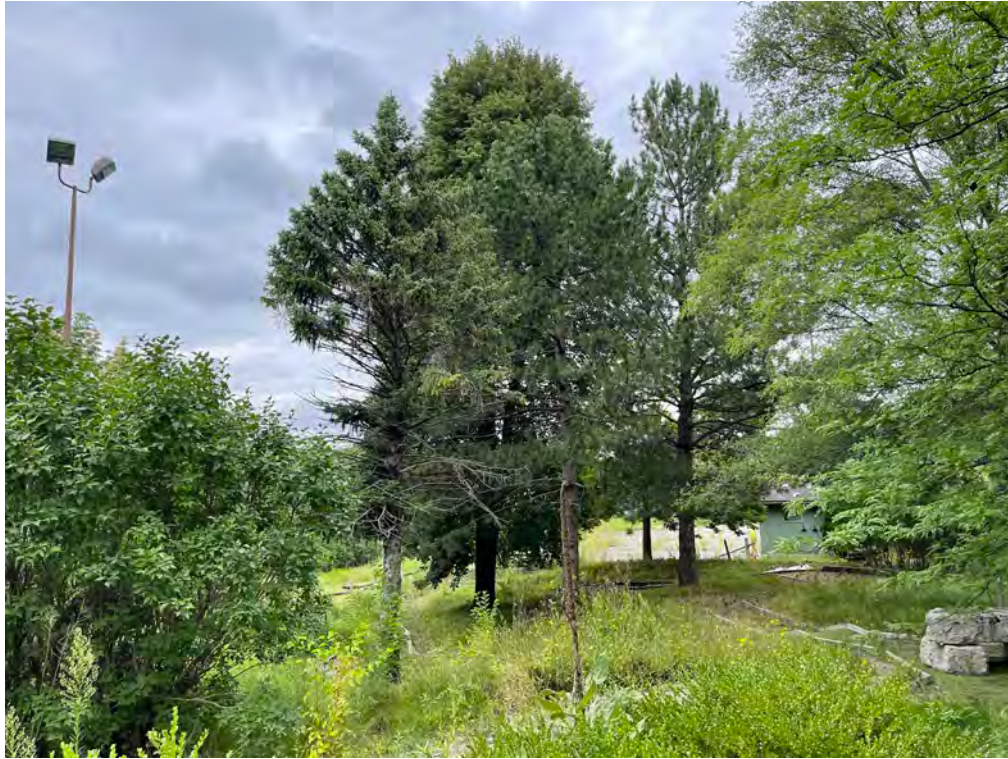
Trees 936 – 939

| 936 | Colorado Blue Spruce | <i>Picea pungens</i><br>var. <i>glauca</i> | 34 | P | Moderate to significant<br>deadwood in canopy | Remove due to<br>construction |
| 937 | Austrian Pine | <i>Pinus nigra</i> | 43 | P | Significant deadwood in<br>canopy | Remove due to<br>construction |
| 938 | Austrian Pine | <i>Pinus nigra</i> | 46 | F/P | Moderate to significant<br>deadwood in canopy | Remove due to<br>construction |
| 939 | Little Leaf Linden | <i>Tilia cordata</i> | 66 | F | | Remove due to<br>construction |

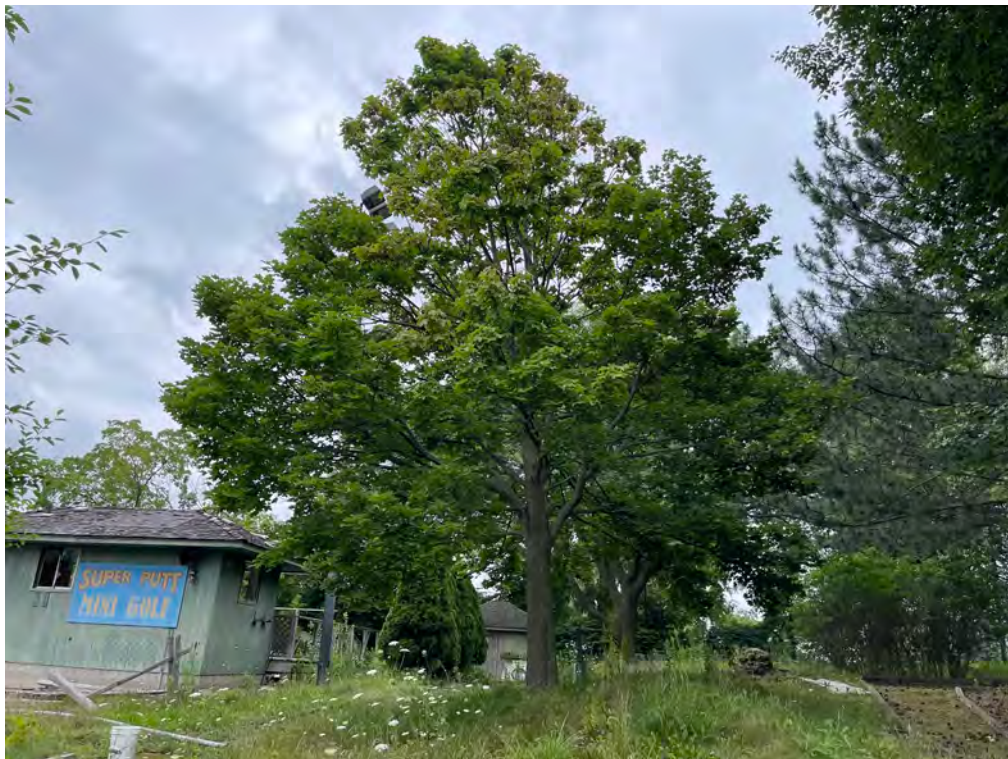
Tree 940

| 940 | Norway Maple | <i>Acer</i><br><i>platanoides</i> | 35 | F | | Remove due to<br>construction |

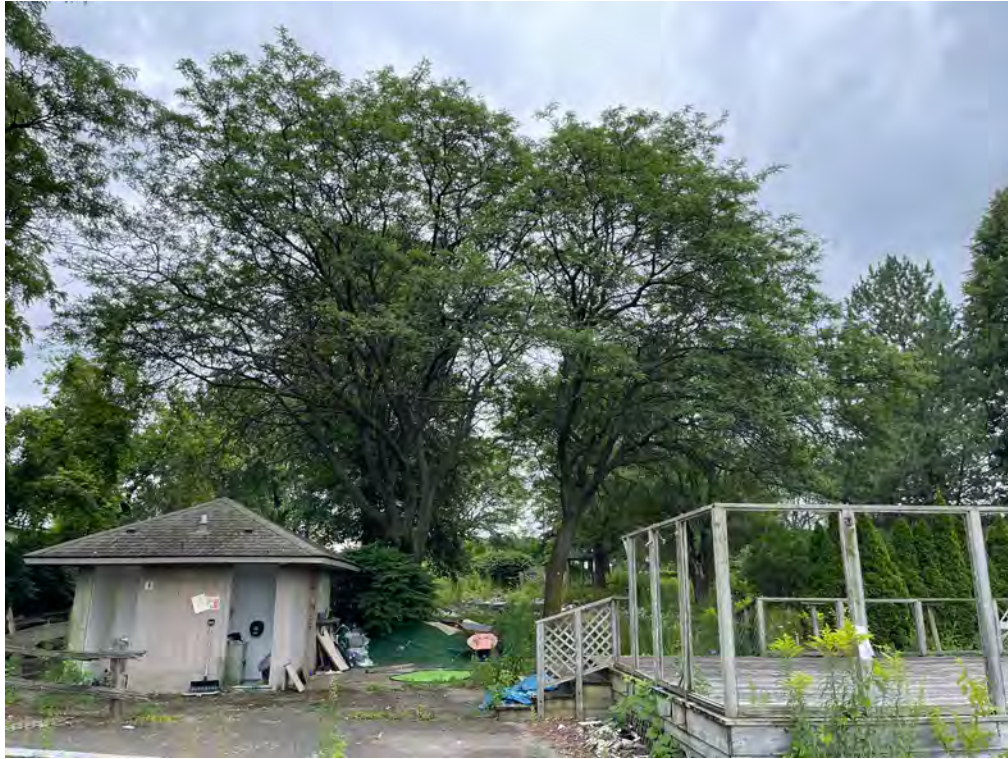
Trees 941, 942

| 941 | Honey Locust | <i>Gleditsia</i><br><i>triacanthos</i> | 50 | F | Moderate deadwood in<br>canopy | Remove due to<br>construction |
| 942 | Honey Locust | <i>Gleditsia</i><br><i>triacanthos</i> | 67 | F | Moderate to significant<br>deadwood in canopy | Remove due to<br>construction |

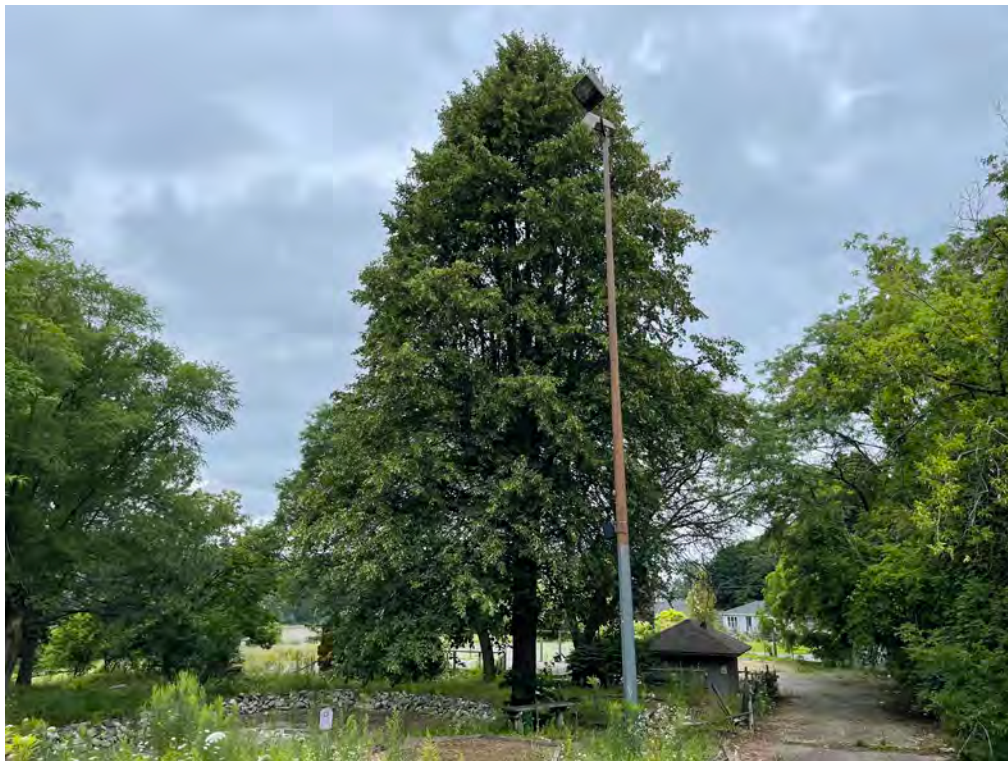
Tree 943

| 943 | Little Leaf Linden | <i>Tilia cordata</i> | 57 | F | | Remove due to<br>construction |

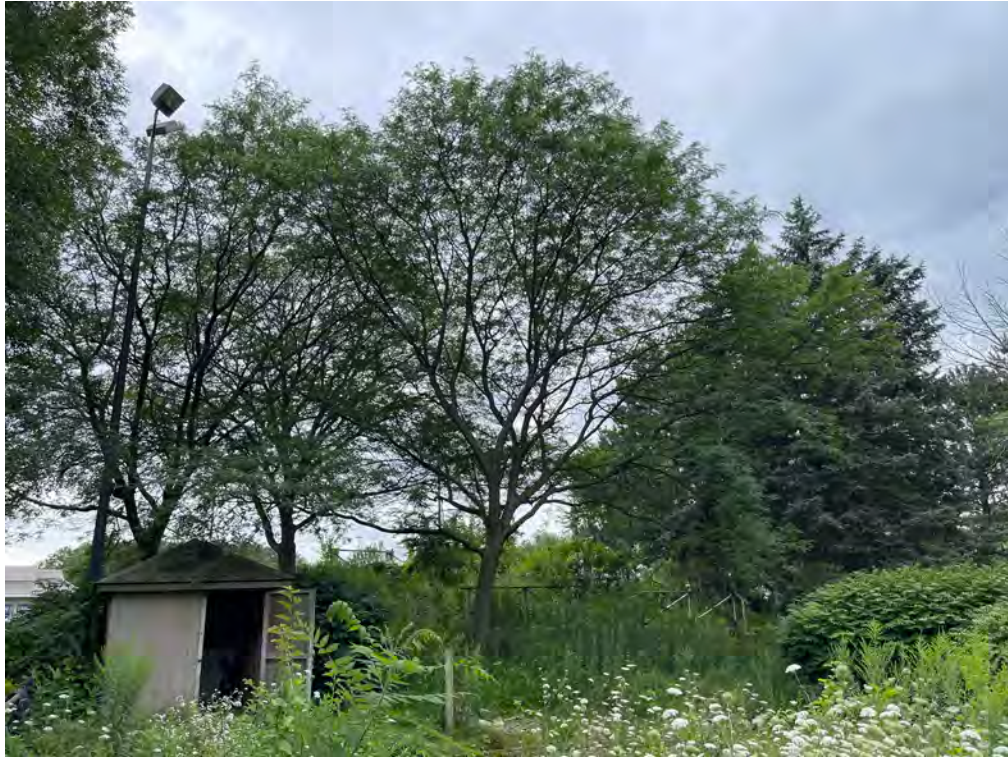
Tree 944

| 944 | Honey Locust | <i>Gleditsia</i><br><i>triacanthos</i> | 36 | F | Minor deadwood in canopy | Remove due to<br>construction |

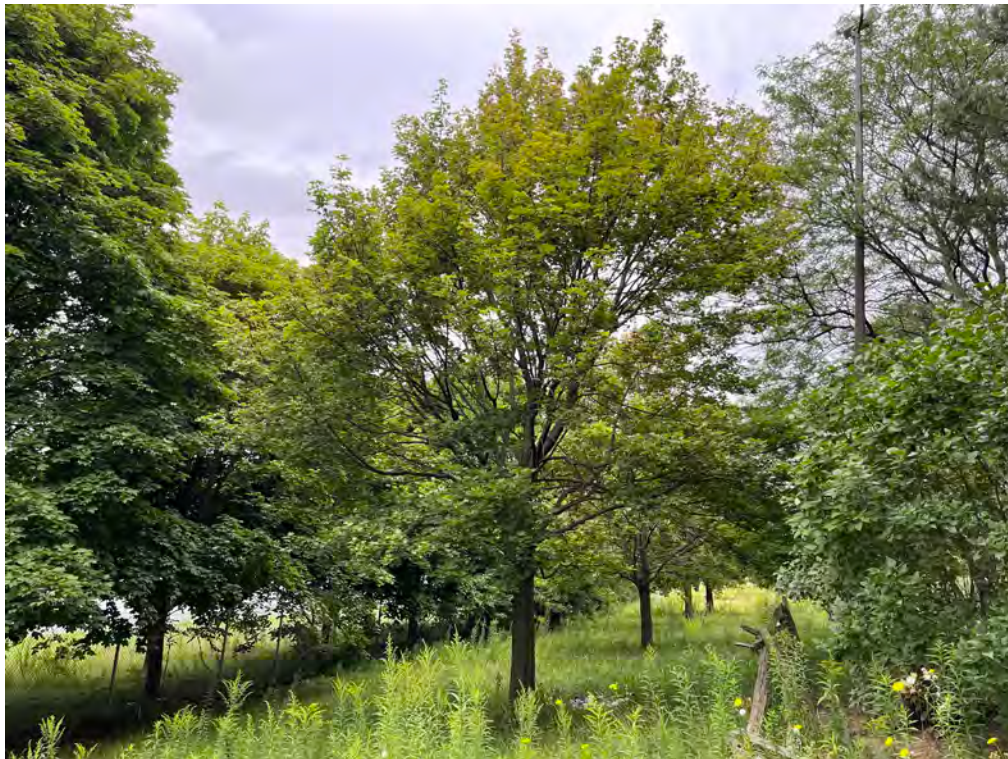
Tree 945

| 945 | Norway Maple | <i>Acer</i><br><i>platanoides</i> | 35 | F | | Retain |

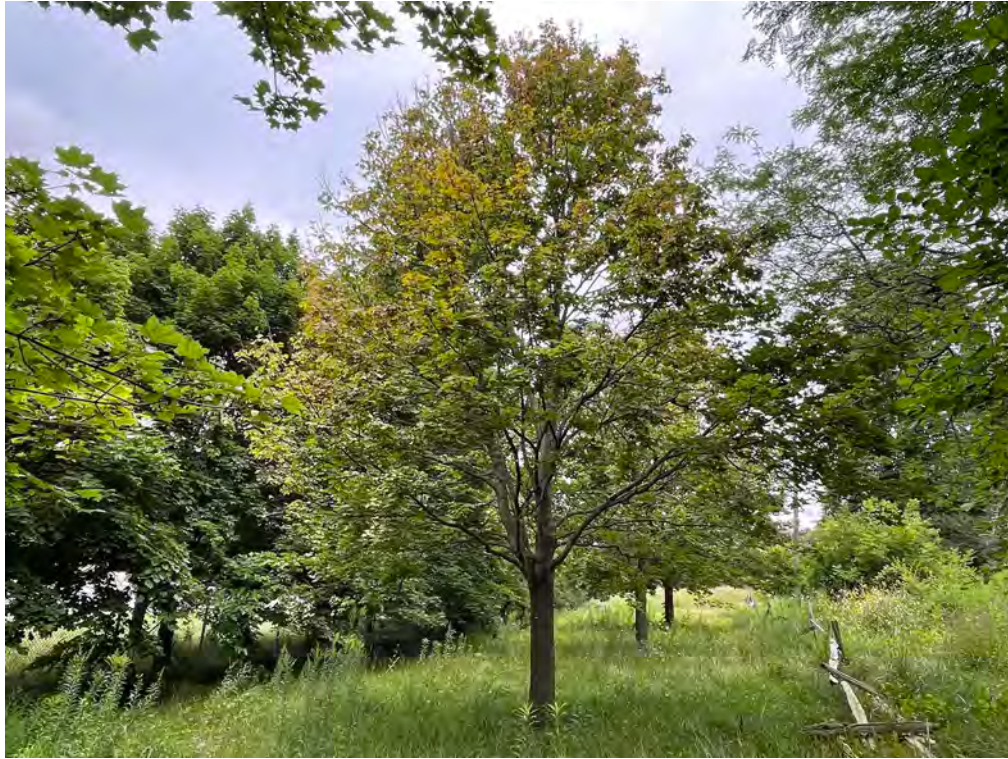
Tree 946

| 946 | Norway Maple | <i>Acer</i><br><i>platanoides</i> | 31 | F | Minor deadwood in canopy | Retain |

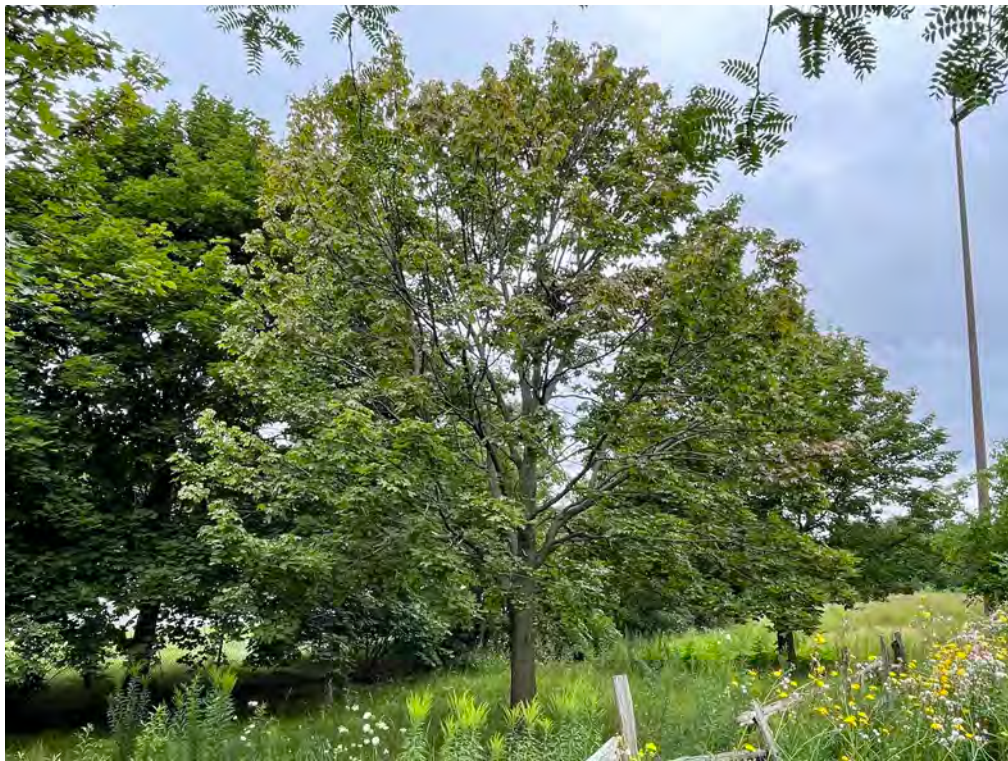
Tree 947

| 947 | Norway Maple | <i>Acer</i><br><i>platanoides</i> | 34 | F | Minor deadwood in canopy | Retain |

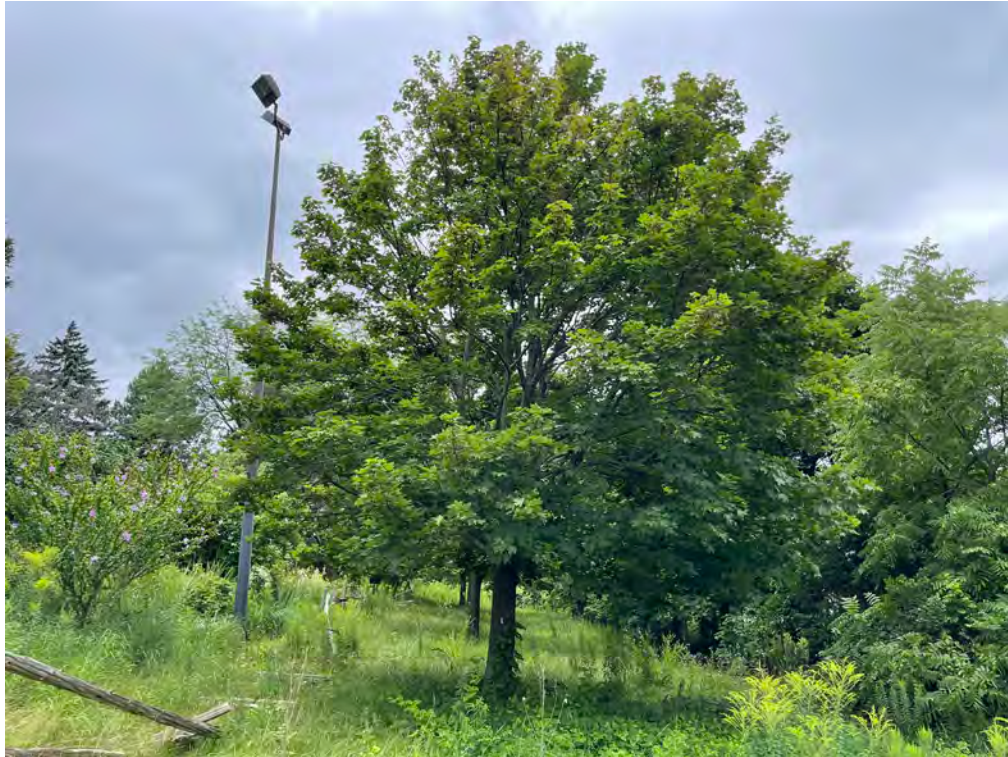
Tree 948

| 948 | Norway Maple | <i>Acer</i><br><i>platanoides</i> | 39 | F | | Retain |

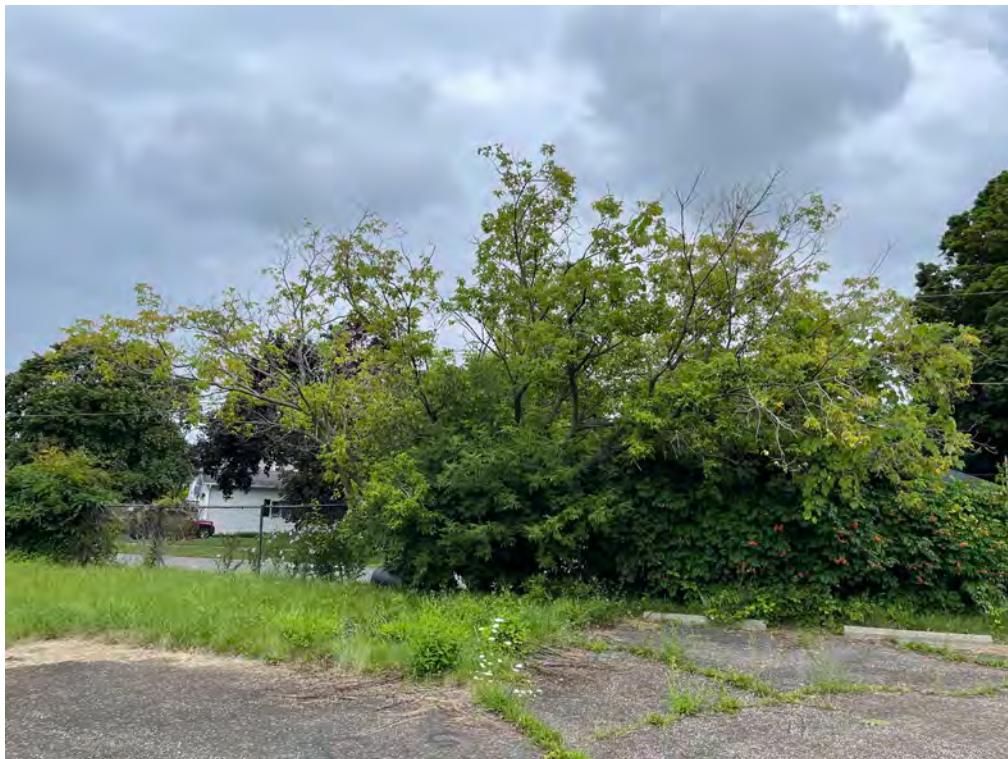
Tree 949

| 949 | Manitoba Maple | <i>Acer negundo</i> | 31 | F | 4 stem at 0.3 metres,<br>growing through fence,<br>minor deadwood in canopy | Remove due to<br>construction |

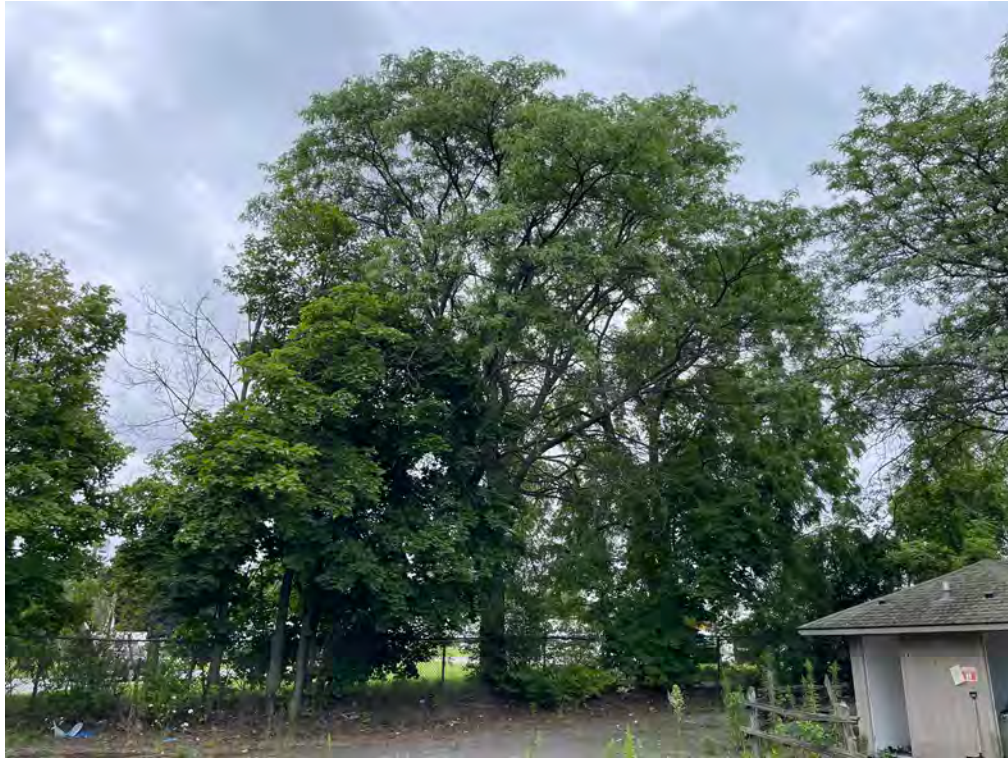
Trees 950 – 957

| 950 | Norway Maple | <i>Acer</i><br><i>platanoides</i> | 23 | F/P | Mildew disease evident,<br>moderate deadwood in<br>canopy, growing through<br>fence | Remove due to<br>construction |
| 951 | Norway Maple | <i>Acer</i><br><i>platanoides</i> | 20 | P | Mildew disease evident,<br>growing through fence,<br>significant deadwood in<br>canopy | Remove due to<br>construction |
| 952 | Norway Maple | <i>Acer</i><br><i>platanoides</i> | 24 | F/P | Growing through fence,<br>moderate deadwood in<br>canopy | Remove due to<br>construction |
| 953 | Norway Maple | <i>Acer</i><br><i>platanoides</i> | 20 | F | Growing through fence | Remove due to<br>construction |
| 954 | Norway Maple | <i>Acer</i><br><i>platanoides</i> | 22 | F | 2 stem at base, moderate<br>deadwood in upper canopy | Remove due to<br>construction |
| 955 | Honey Locust | <i>Gleditsia</i><br><i>triacanthos</i> | 71 | F/P | Moderate to significant<br>deadwood in canopy | Retain |

| 956 | Norway Maple | Acer platanoides | 15 | F | | Retain |
| 957 | Black Walnut | Juglans nigra | 92 | F | Minor deadwood in canopy, co-dominant limbs fused at 2.0 metres | Retain |

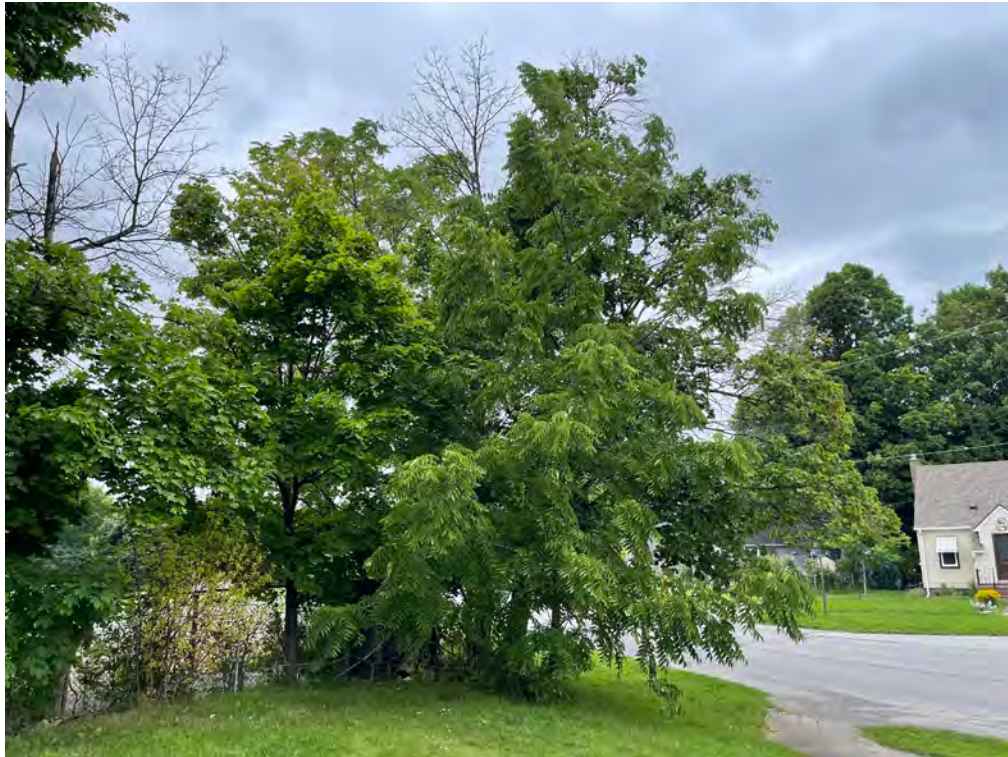
Trees 958 – 962

| 958 | Norway Maple | Acer platanoides | 20 | F | Minor deadwood in canopy | Retain |
| 959 | Norway Maple | Acer platanoides | 15 | P/D | Growing through fence, tree is 50% dead | Remove due to construction |
| 960 | Norway Maple | Acer platanoides | 15 | F/P | Growing through fence, moderate lean, moderate deadwood in canopy | Retain |
| 961 | Norway Maple | Acer platanoides | 37 | P | Moderate to significant deadwood in canopy, mildew disease evident, 2 stem at base | Retain |
| 962 | Black Walnut | Juglans nigra | 13 | F | | Retain |

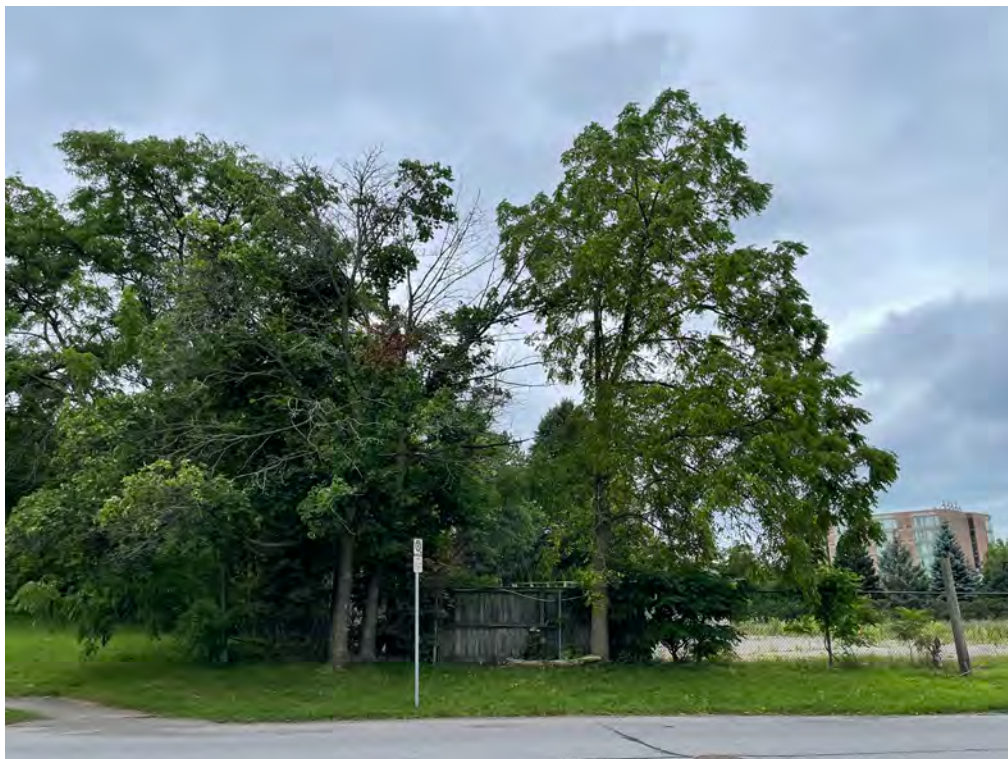
Trees 961 – 963

| 963 | Black Walnut | Juglans nigra | 37 | F | Minor deadwood in canopy | Retain |

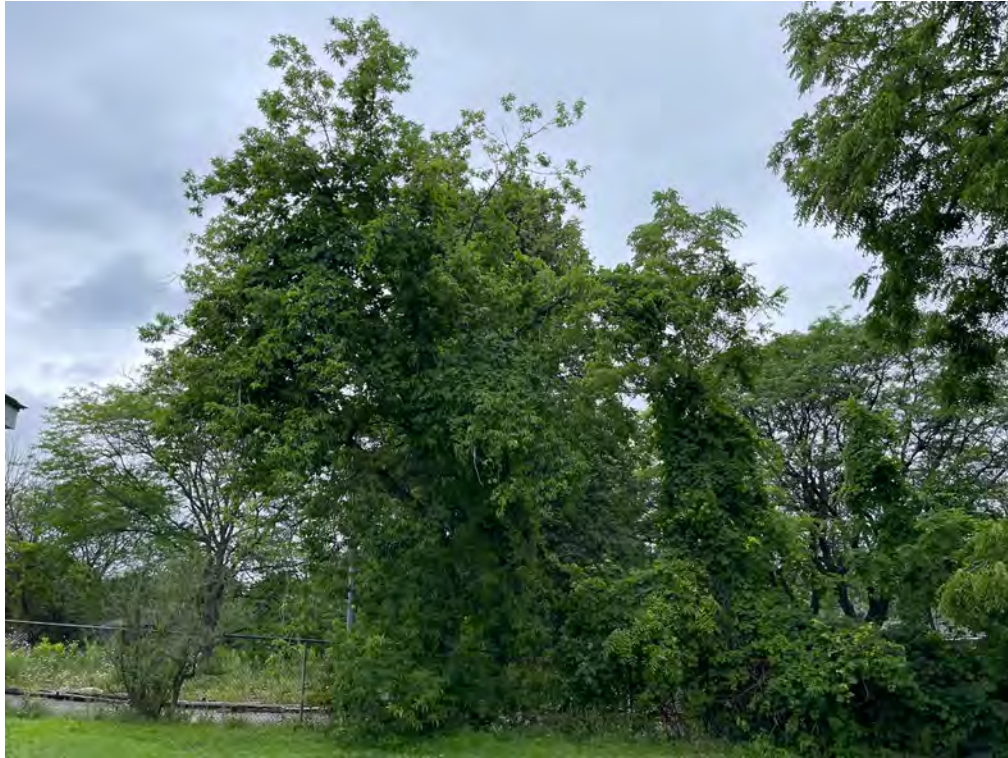
Trees 964, 965

| 964 | Black Walnut | Juglans nigra | 15 | F/P | Elevated canopy, vines growing throughout | Retain |
| 965 | Manitoba Maple | Acer negundo | 36 | F | Vines growing throughout | Retain |

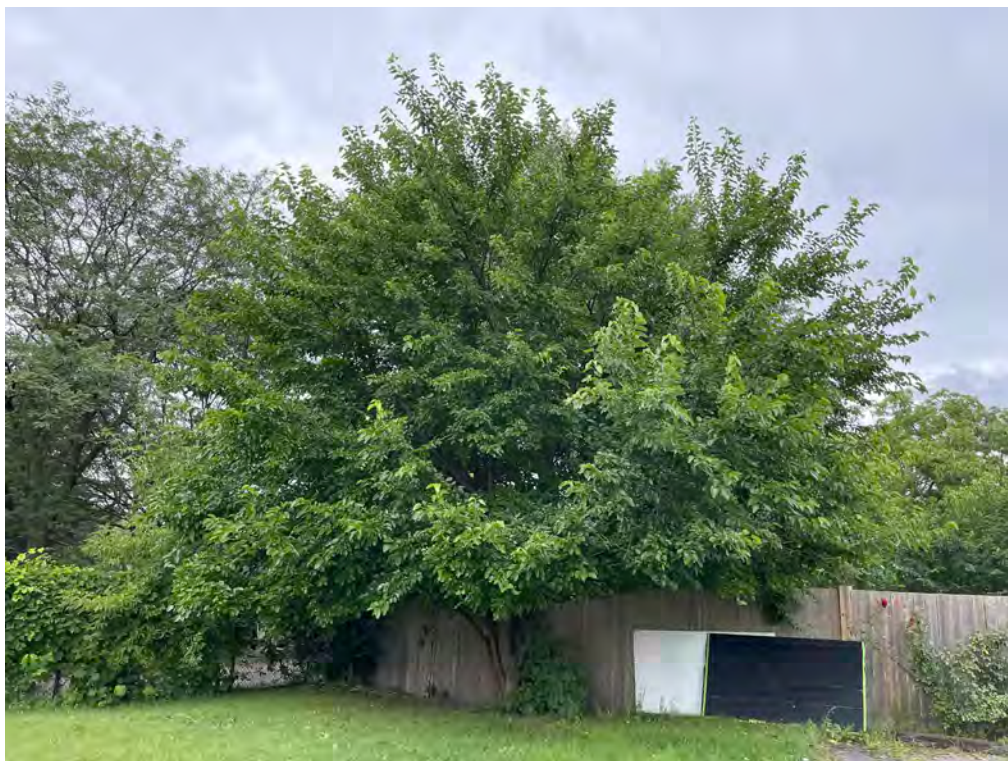
Tree 966

| 966 | White Mulberry | Morus alba | 17 | F | | Retain |

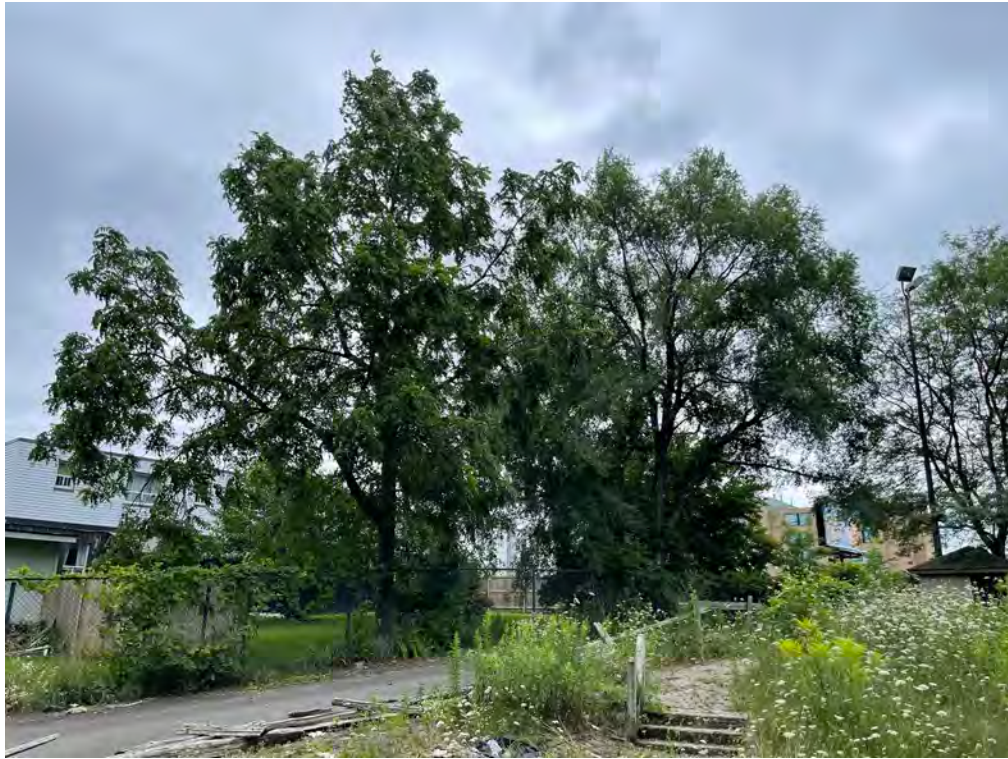
Trees 967, 968

| 967 | Siberian Elm | Ulmus pumila | 62 | F | Minor deadwood in canopy, vines growing throughout | Retain |
| 968 | Black Walnut | Juglans nigra | 39 | F | Minor deadwood in canopy | Retain |
