Anthony Vacca  
8178 Thorold Stone Road, Niagara Falls

*Tree Inventory and Tree Protection Plan*  
**March 2023**

**Prepared By**  
**Kaitlyn Simpson - Certified Arborist**

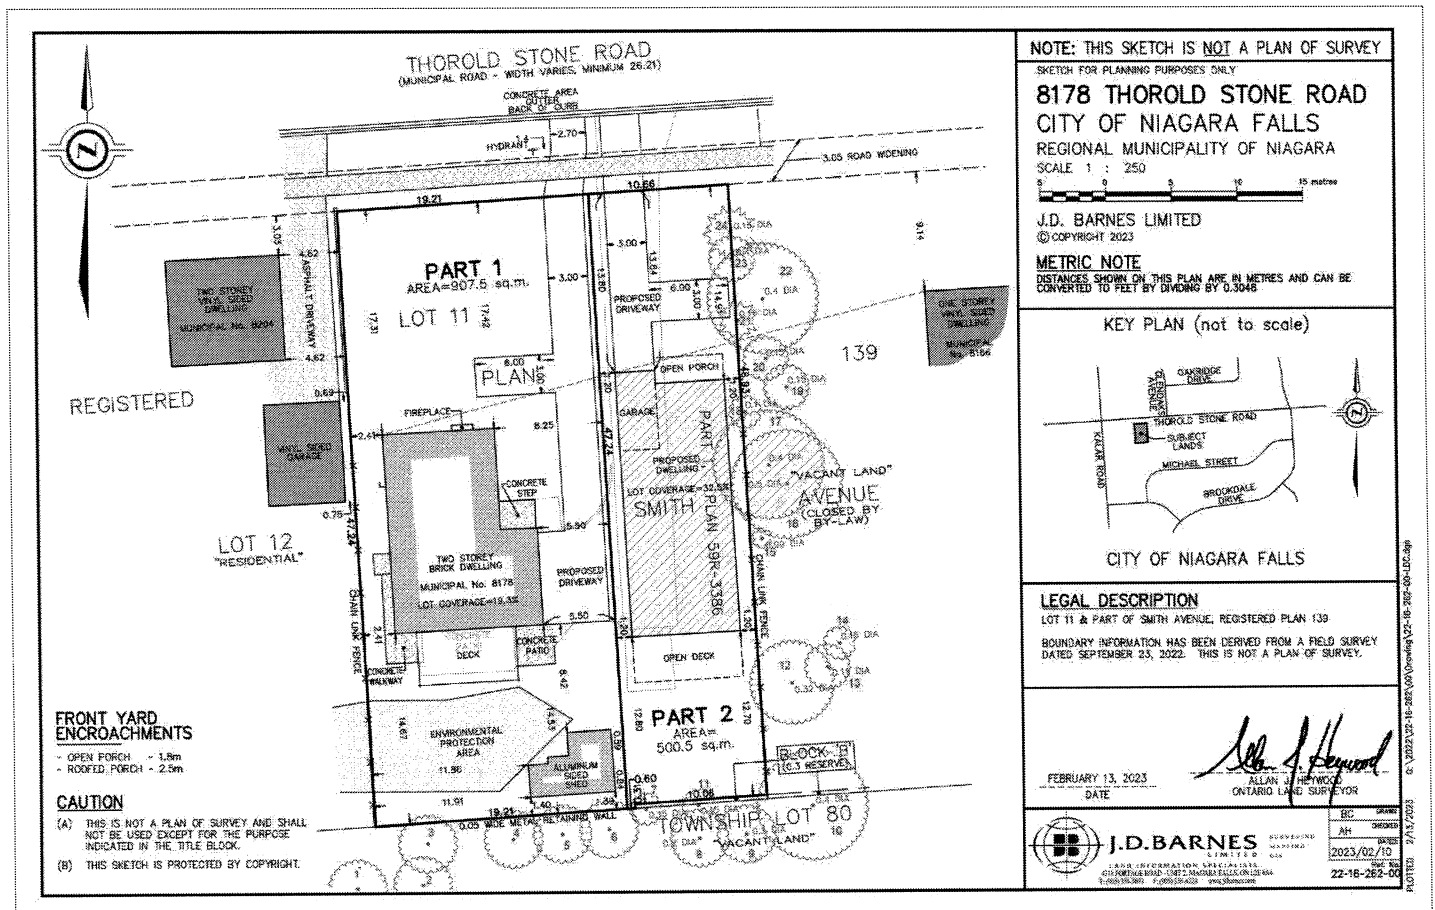
Figure 1 the site survey for the property in question. Red numeric values are relative to the tree inventory numbers in section 3.1 of this document.

**Removals due to health: 1, 2, 11, 13, 15, 18, 19.**

**Removals due to proximity to the proposed construction: 16, 17, 20**

**Tree Pruning due to proposed construction: 17, 23.**

After assessment, it is recommended that the following trees have a Tree Protection Zone, as per figure 1 below, installed for the duration of the proposed construction:

10, 12, 21, 22.
